VIBRATION IMPROVEMENT MODIFICATIONS

LIGHT TABLE

**NPIC/R-08/73
MARCH 1973**

TEST REPORT

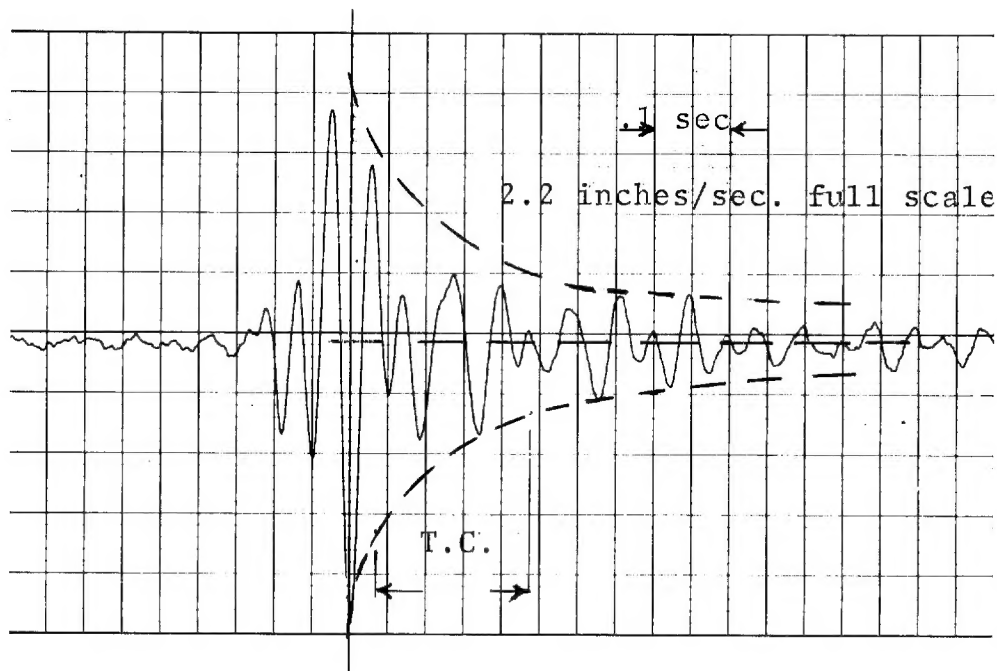
Figures 6 and 7 show typical time responses of the bridge beam before and after it had been modified. The other modifications are not related to the time constant associated with visible image vibration. It can be seen that the time constant for the modified bridge beam (.20 sec.) is less than one-half the time constant of the standard beam (.42 sec.). It should also be noted that the standard beam lingers at maximum vibration amplitudes while the modified beam starts to die down immediately. The overall effect is shorter bursts of image vibration with the modified beam.

Figure 6: Time Constant for the Stiffened/
Dampened Bridge Beam. Time Constant Equals
.20 Second.

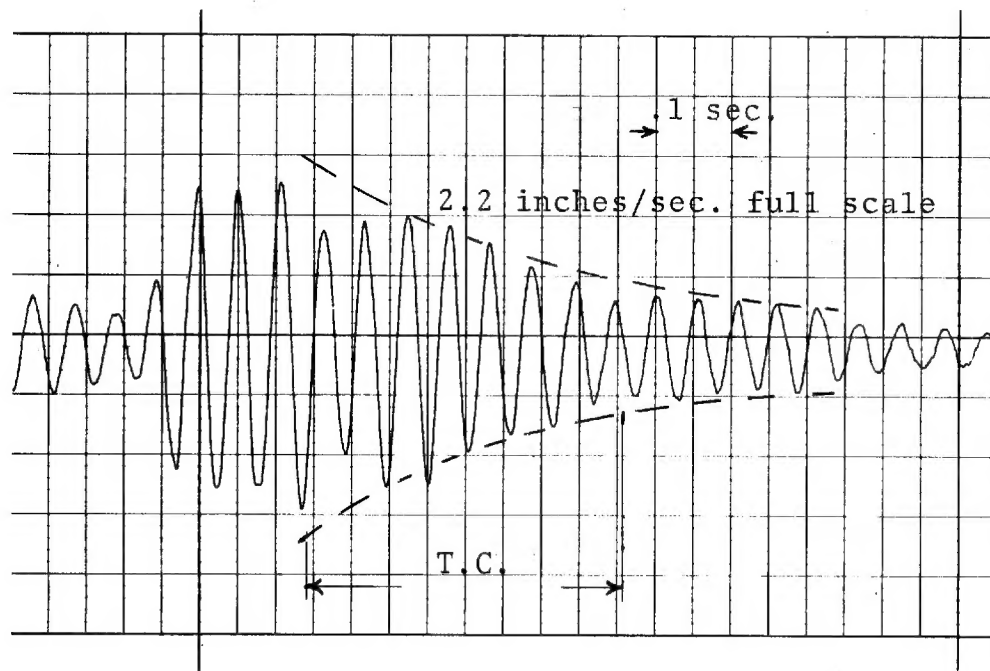
Figure 7: Time Constant for a Standard
Bridge Beam. Time Constant Equals .42
Second.
